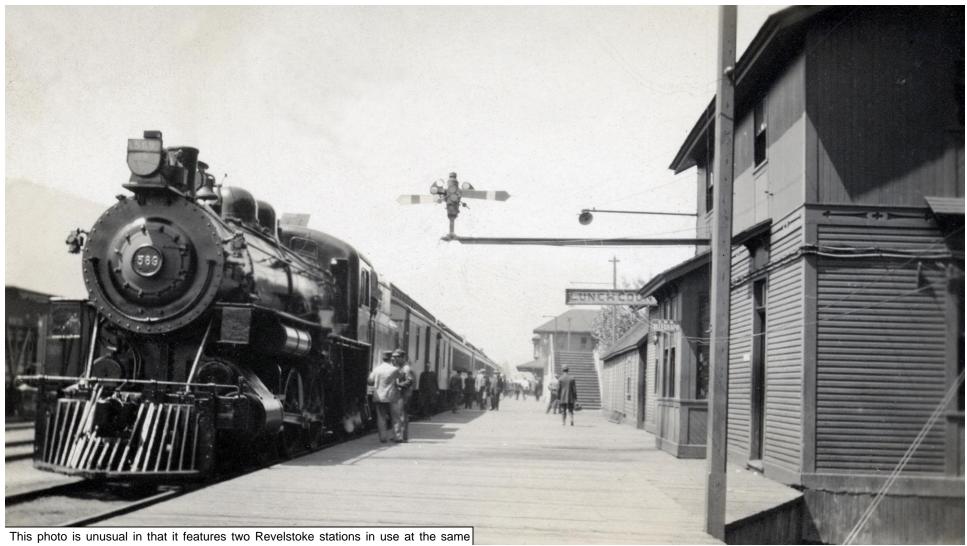
Revelstoke Railway Museum Photo #1592 Photographer unknown

time. The date is some time after July 1905 as the new station, in the distance, was completed at that time. The train is being prepared for its trip eastbound and we see the locomotive crew discussing their coming assignment.

The earlier station, in the foreground, is still in operation as a train order office. In the distance, between the two stations is a staircase leading up to a landing. There is a similar staircase leading up from the new station. From the landing another staircase leads up to the CPR hotel on the hillside above. At this time the wood plank passenger platform spans the two stations. In later years the platform was shortened and paved prior to 1938. After the hotel on the hillside was closed and torn down in 1929 the staircases were removed and a lower concrete retaining wall was built to prevent any slippage of the hillside.

As stated on page 9, No. 589 was built by Schenectady Locomotive Works of New York in 1903. It was converted from a compound to a simple locomotive, as seen here, 13 in June 1910 so that dates the photo as subsequent to June 1910.

The D9 classes were used in passenger service for many years on the Revelstoke Division. In January 1916 there were eleven D9s assigned to Revelstoke for passenger service. They were replaced in this service by more powerful locomotives such as the G4 Pacifics in 1919. When the larger locomotives arrived, the D9s still remained in service in lesser roles. This would have included the Lake Windermere, Arrow Lakes and Okanagan subdivisions. Indeed, D9c No. 590 was still assigned to Revelstoke in June 1954. So based on all this information, the photo was most likely taken after June 1910 and prior to the arrival of the G4 Pacifics in 1919.

The train appears to be about six or seven cars long, perhaps as many as eight and may not have included a dining car. A meal stop would take place at Glacier House if necessary. The D9s were restricted to about 850 tons between Revelstoke and Albert Canyon and about 400 tons between Albert Canyon and Glacier, so depending on the weight of the train, a pusher was probably added at Albert Canyon. Prior to 1916 this would have been an N3 2-8-0 or an R1 2-10-0 if it was later than 1916.
